Condition Assessment of Streambanks and Streamside Vegetation on Perennial Streams in Wind Cave National Park

2009-2012

Natural Resource Technical Report NPS/WICANRTR—2013/758

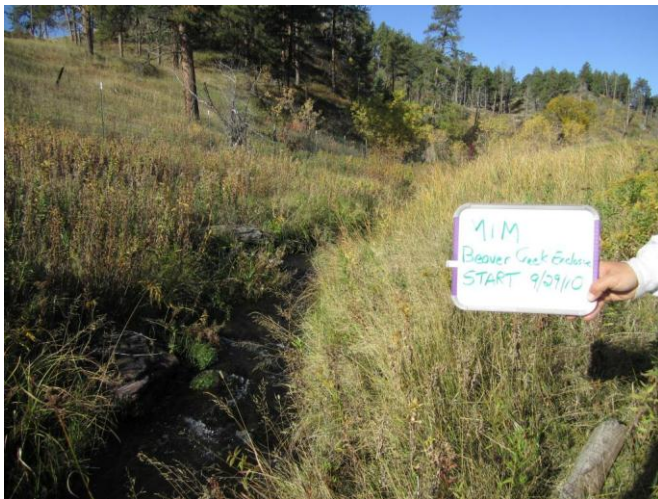
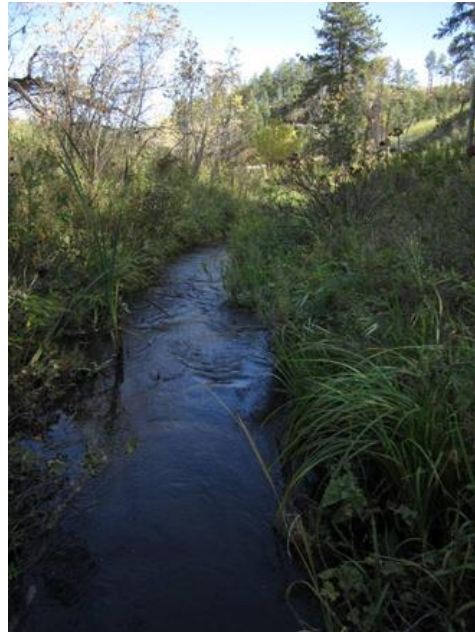
Beaver Creek Exclosure - 2010

Beaver Creek Exclosure parameters are useful in describing an area of low wildlife use for 17 years. There was no change in condition between 2009 and 2012 (indicator/metric differences were within confidence intervals). Stubble height is high relative to other DMAs; percent bank alteration is very low; percent covered banks is very high; percent stable banks is high.

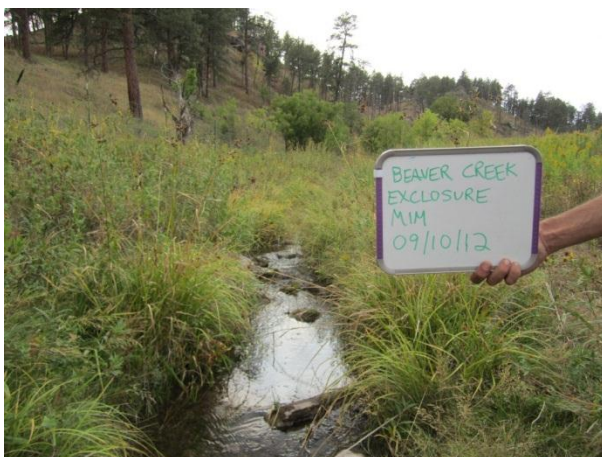
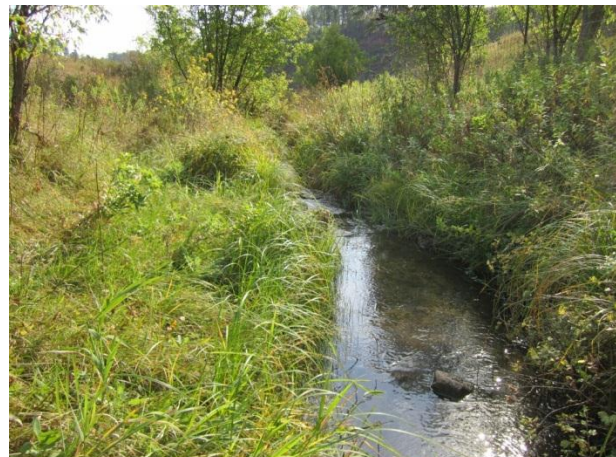
Beaver Creek Exclosure - 2012

Beaver Creek Exclosure metrics for wetland rating, Winward greenline rating, and greenline ecological status rating considered together indicate poor condition. This was not expected if recovery from pre-exclosure disturbance/wildlife use has been substantial. The data and analysis indicate that Beaver Creek Exclosure is not in a condition of resilient streambanks vegetated with high cover of perennial hydric species (including shrubs) with deep roots that stabilize banks and store water. Additional investigation is needed to determine whether native, hydric, woody, species are likely to become established in this exclosure.

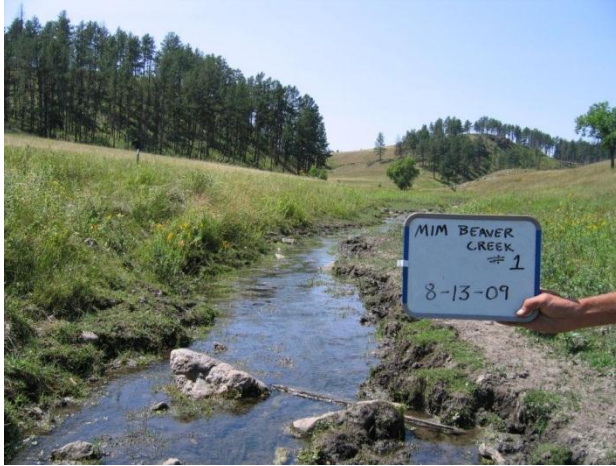
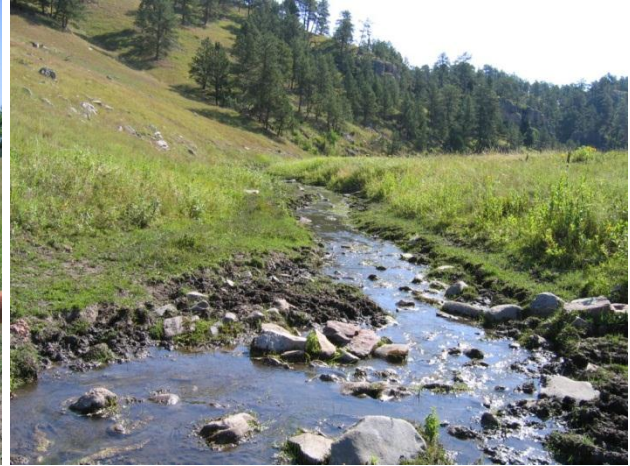
Beaver Creek 1 - 2009

There was no change in condition in Beaver Creek 1 DMA between 2009 and 2012 (indicator/metric differences were within confidence intervals). MIM streamside vegetation parameters (mean stubble height, dominant key species, height of dominant key species, plant diversity index, percent hydric herbaceous species, woody species composition) for Beaver Creek 1 indicate that grazing of streamside vegetation was extreme. The ratio of mean stubble height in 2012 Beaver Creek 1 DMA (3 in) to mean stubble height in 2012 Beaver Creek Exclosure DMA (16.2 in) is 18.5%, indicating greater than 80% of plant material removed. This

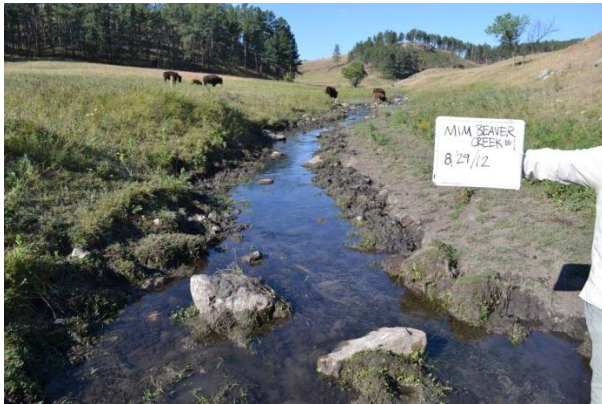
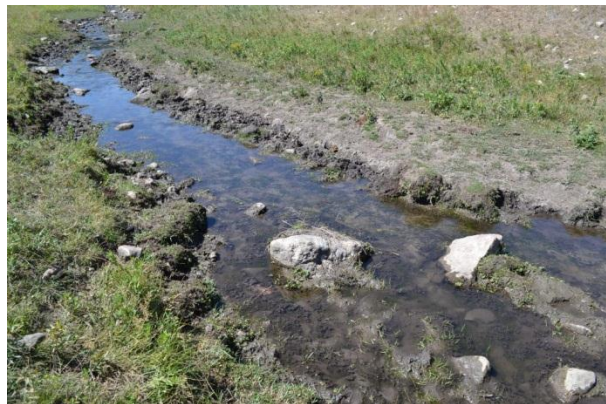
Beaver Creek 1 – 2012

Beaver Creek 1 DMA metrics for wetland rating, Winward greenline rating, and greenline ecological status rating considered together indicate poor condition. Plant species appropriate for a wetland are present, but erosional resistance is mid to low and ecological status is very early.

MIM protocol suggests estimating repair after disturbance by measuring both streambank alteration and streambank stability after the grazing period and then again just before the next grazing period. This is possible when examining impacts from livestock managed with on-off seasonality. There is no off-season in WICA for wildlife use of streams. Repair necessary to support healthy streambanks in WICA must occur through managing wildlife population sizes, protecting areas with exclosures, providing off-stream water sources, managing predators to discourage wildlife from lingering on streams, and/or other means.

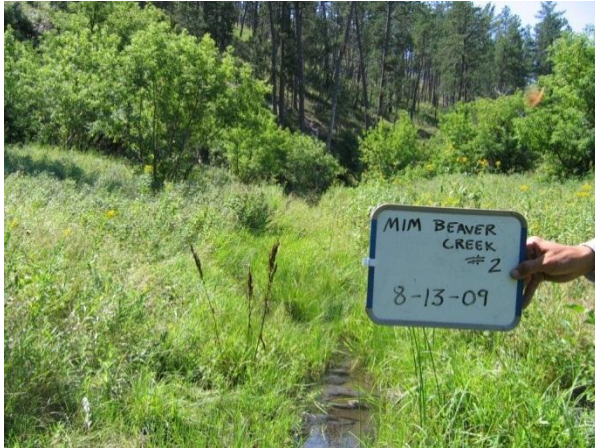
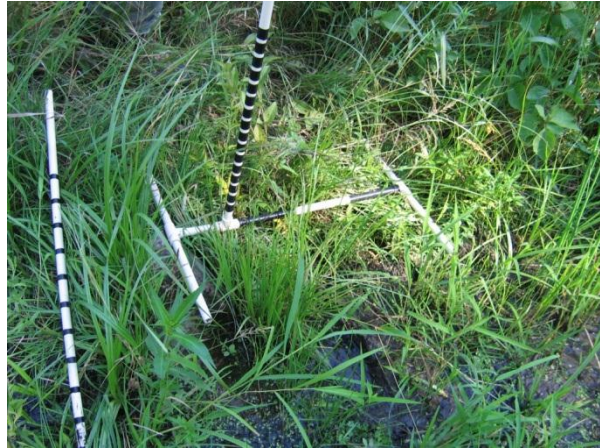
Beaver Creek 2 – 2009

Beaver Creek 2 metrics for wetland rating, Winward greenline rating, and greenline ecological status rating taken together indicate poor condition. Although plant species appropriate for a wetland are present, erosional resistance is only moderate and ecological status is early.

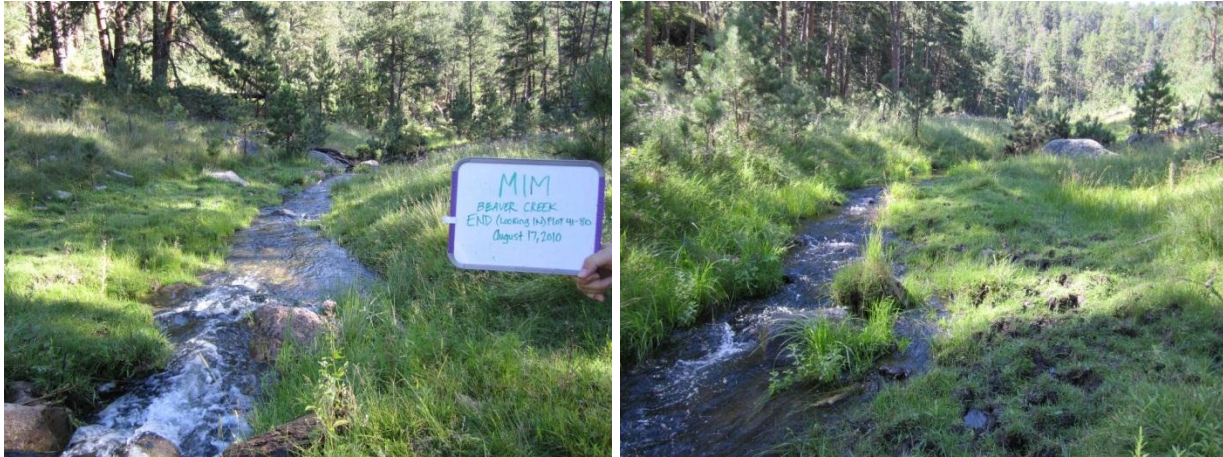
Beaver Creek 3 – 2009

Beaver Creek 3 metrics for wetland rating, Winward greenline rating, and greenline ecological status rating taken together indicate poor condition. Species appropriate for a wetland are present, but erosional resistance is mid and ecological status is very early.
